# Mobile Pentium® II Processor Specification Update

Release Date: December 1999

Order Number: 243887-016

The Mobile Pentium® II processor or the Intel® Pentium® II Processor Mobile Module may contain design defects or errors known as errata which may cause the product to deviate from published specifications. Current characterized errata are documented in this Specification Update.

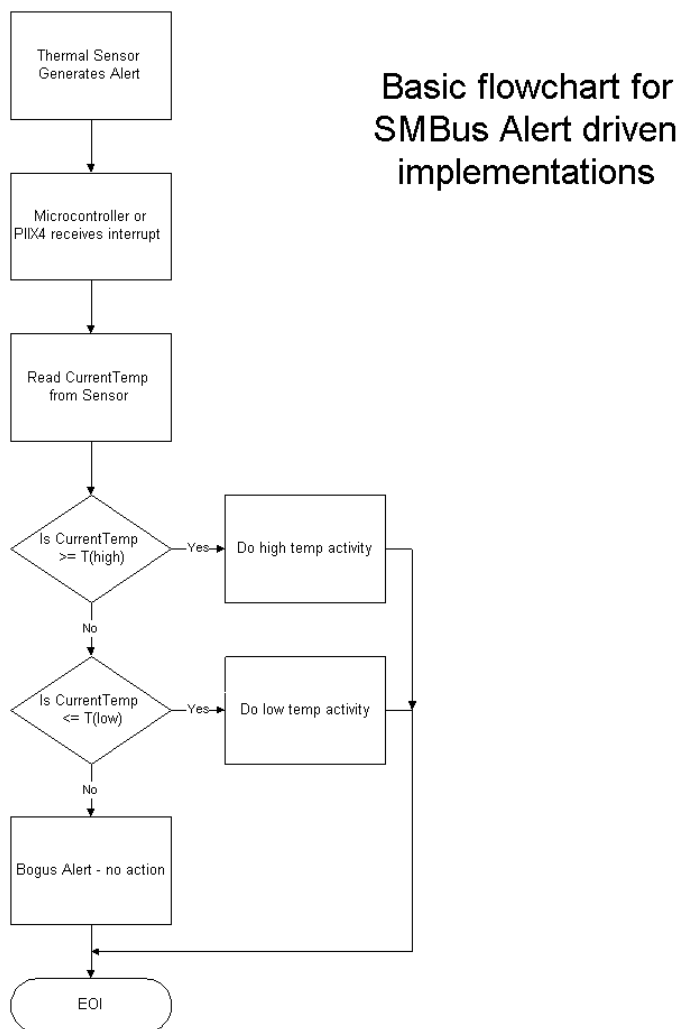
Figure 2. Workaround Flowchart: SMBALERT#-Driven System

Under the conditions described below, the thermal sensor incorrectly generates the SMBALERT# interrupt. All of the following conditions must be met to trigger a false interrupt:

1. Before servicing an interrupt from the thermal sensor, read and compare the processor thermal reading with the threshold limits ( $T_{HIGH}$  or  $T_{LOW}$ ). Figures 2 and 3 provide basic flowcharts for the implementation of this workaround in an interrupt driven system.
2. If the firmware implemented polls the Status Register only, then before taking any action, re-read the temperature register and do a comparison with the alarm threshold limits ( $T_{HIGH}$  or  $T_{LOW}$ ) to determine if the value is actually still within the temperature window.

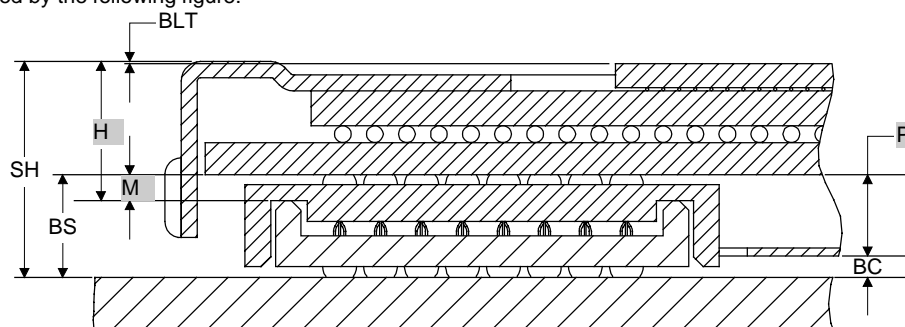
**Figure 5.6. Cross Sectional View with Vertical Dimensions**

### B1. Misabeled Vertical Dimension Parameters

Figure 5.6 in the *Mobile Pentium® II Processor at 233 MHz, 266 MHz, and 300 MHz* datasheet should be replaced by the following figure:

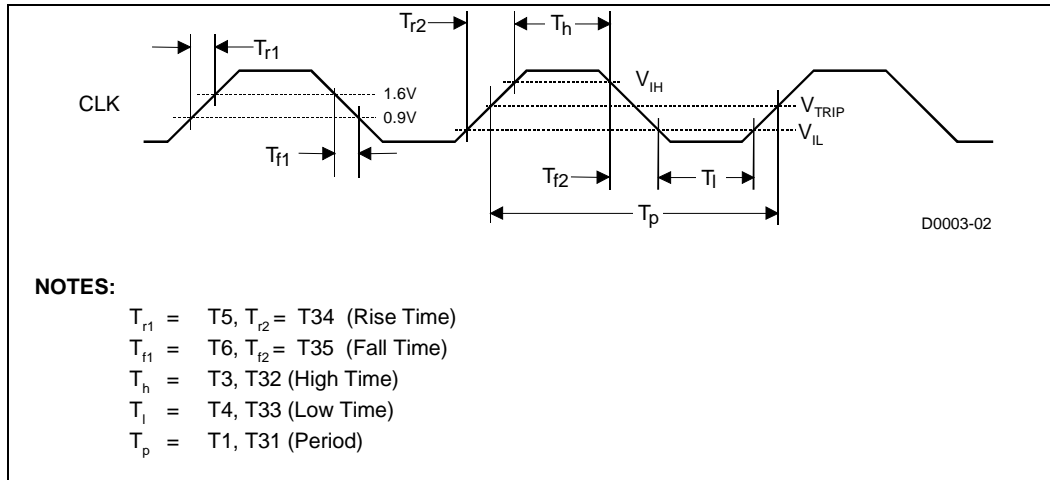
**Figure 3.3 Generic Clock Waveform**

### **B14. Generic Clock Waveform Figure**

Figure 3.3 in *Mobile Pentium® II Processor in Mini-Cartridge Package at 366 MHz, 333 MHz, 300PE MHz, and 266PE MHz* datasheet (Order Number 245108), and the *Mobile Pentium® II Processor in BGA Package at 366 MHz, 333 MHz, 300PE MHz, and 266PE MHz* datasheet (Order Number 245106) has been updated. The following figure is to replace the ones in the above documents.
